ICING TEST REPORT

KfobiX - SPH Anti-Icing Coating

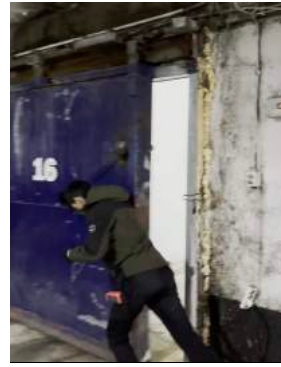
Figure 1

Ice formation tests were carried out by renting the "PORTAŞ-BELKO Cold Storage" number 16 within the Ankara Metropolitan Municipality, between the dates of February 29, 2024, and March 2, 2024 (Figure 1). The ambient temperature of the cold storage was set to a constant -18°C , 24 hours before the start of the tests, and the temperature and humidity values of the depot were continuously monitored with laser thermometer measurements. The temperature in different parts/areas of the cold storage, pre-cooled before the test, was measured between -22°C and -16°C right before the start of the test (Figure 2). A military-standard trail camera, placed at a distance where it would not be affected by humidity and water droplets could not adhere to the surface, took instant photographs every 20 minutes throughout the test duration (Figure 3).

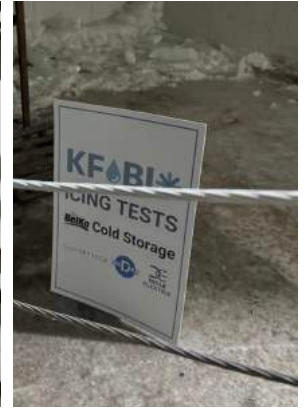
Figures 4 and 5 depict the pre-test visuals of the conductive wires. Approximately 2-meter-long conductive wires were placed in an arrangement with the coated wire above and the reference wire below. The conductive wire seen at the bottom in Figure 4 is the reference wire and is grey in color (the natural color of steel-core aluminum wire). The wire seen at the top in Figure 4 is coated with "KFOBIX SPH Anti-Icing" coating. As observed, after the application, *the color of the conductive wire has changed to a pale white. It is important to note that this is not ice accumulation, but the color of the wire after the coating. Coatings of different colors could also be applied.*

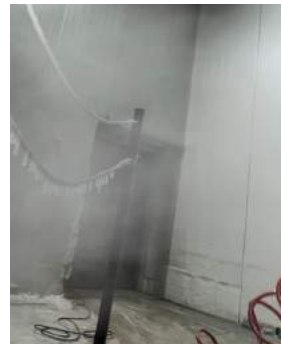
Figure 6

1. To increase the ambient humidity, water was sprayed into the environment using a compressor-spray gun. The regional ambient humidity was continuously maintained above 70% (Figure 6).
2. A total of 1.5 liters of water was poured over each wire using a gallon bottle water (Figure 7).
3. With the help of a pipette, approximately 0.25mL of water was dripped along the conductive wires, accelerating the adherence of water droplets on the surface of the wires (Figure 8).

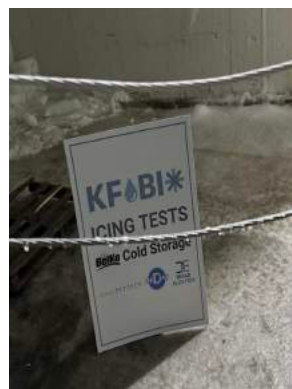
Figure 11

After the first icing test cycle, no icing or nucleation was observed on the conductive wire coated with "KFOBIX SPH-Anti-Icing" (above), while nucleation had occurred on the uncoated reference wire (below), with partial icing beginning (Figure 11).

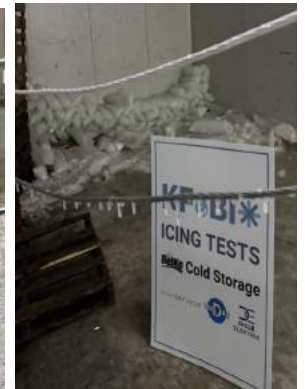
Figure 12

After the third test cycle, no icing was observed on the coated wire, while icing on the reference wire increased, and ice icicle became pronounced. The combination of high ambient humidity, water poured onto the conductive wires, and low temperatures resulted in the nucleation points gradually growing into icicle. By the third cycle, ice icicle approximately three times the thickness of the reference wire was observed (Figure 12).

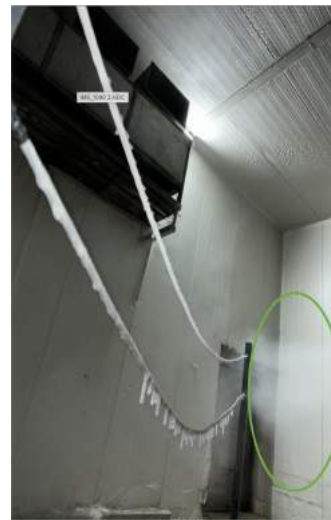
Figure 16

The ninth stage of the cycle process is presented in Figures 16 and 17. In the ninth cycle, icing on the reference wire has dramatically increased, with ice icicle reaching approximately five times the thickness of the wire. Additionally, as seen in the leftmost part of the reference wire in Figure 16, the wire is completely encased in ice. The conductive wire is entirely covered in ice. On the other hand, no ice icicle or accumulations are observed on the coated wire. As mentioned above, only an increase in the number of nucleation's is observed. This is due to the combination of maintaining high regional ambient humidity (above 70%) (Figure 16 green circle, Figure 17 blue circle) and instantly raising the moisture level of the conductive wires to 100%, followed by pouring water on the wires. Even maintaining the regional ambient humidity above 70% has resulted in icing in the immediate area a ceiling is 8.5 meters) (Figure 17 red circle).

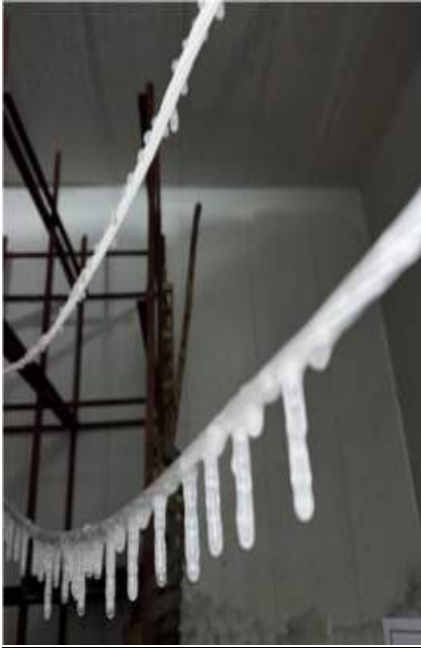
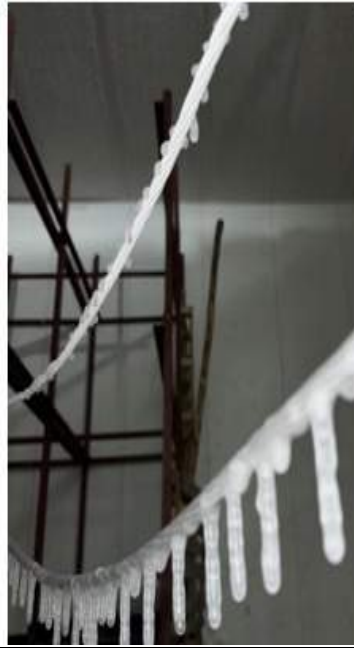
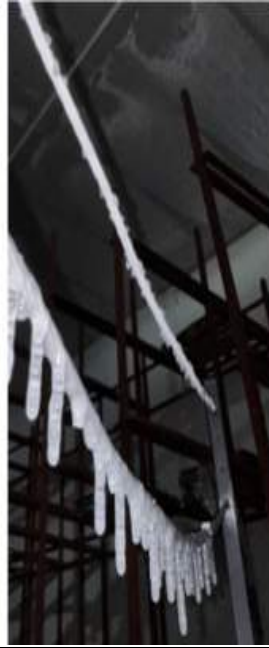
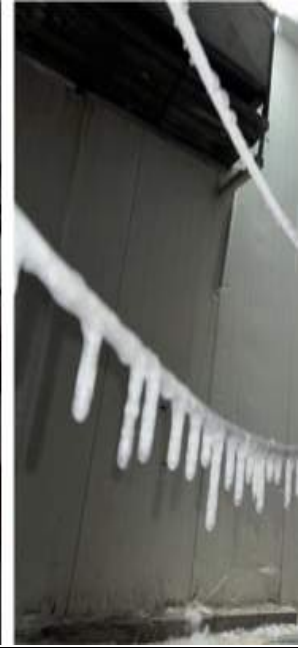
After the final cycle of the test, the 15th test cycle, the final states of the conductive wires are given in Figures 18, 19, 20, and 21. The images show that no ice icicle have formed on the coated wire. Only the nucleation's on the upper surface of the wire have grown, resulting in negligible accumulations. The nucleated ice spheres on top of the wire are sparse and have not shown any formation on the lower region of the wire. Additionally, laboratory tests have proven that the "KFOBIX SPH-Anti-Icing" coating not only prevents or delays icing but also reduces the adhesion strength of ice. During this test, it was observed that the adhesion force of the sparse hemispherical ice particles formed on the upper part of the wire was very low. With a slight force, the ice particles immediately detached from the wire's surface. Thanks to this critical feature, any external factor (such as wind) causes the incompletely adhered ice spheres on the conductive wire to lift from the surface. This property of the KFOBIX SPH-Anti-Icing coating is due to the low solid-liquid and solid-solid contact surface area at the nano level.

In the 15th cycle, the reference conductive wire was completely iced over. By the end of the test, the lengths of the icicle had reached approximately seven times the thickness of the wire, and the icicle had thickened further. Particularly in the middle of the conductor, it was observed that the icicle merged from their points of formation to create even larger accumulations. A more significant problem was that the ice completely enveloped the conductive wire, causing a serious increase in the wire's thickness (Figure 22). As seen in Figure 22, due to icing, the thickness of the conductive wire increased by approximately 1.5 times at the ends and 2.5 times in the middle points. This thickness is due to the ice accumulation surrounding the wire, which, together with the icicle, imposes a significant proportional load on the conductive wire.

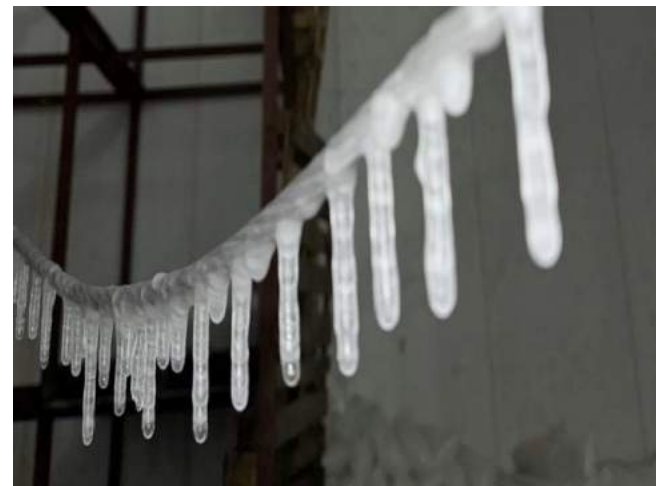
Figure 22

The initial weight of the conductive wire coated with KFOBIX SPH-Anti-Icing was 186.5 grams, and after the 15-cycle icing test, its weight was measured at 191.1 grams. Only an additional 4.6 grams of ice load was added to the wire, with the ice formation increase rate by weight calculated as 2.47%. On the other hand, the reference conductive wire was measured at 195.6 grams before the test, and its weight after the icing test is 274.6 grams. The wire received an ice load of 74 grams, with the ice formation increase rate by weight being 40.38%.

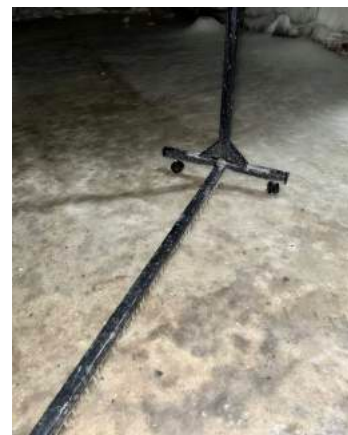
Figure 23

hanger they were suspended on during the test. As seen in Figure 23, the metal hanger and the floor of the depot were also completely iced over during the test. In Figure 24, the volume of ice encasing the reference wire could only be difficultly removed by scraping off the surface with a knife. Throughout the test process, the KFOBIX team (Figures 25-a, 25-b) and the BELKO team (Figure 25-c) monitored the testing procedures.
